Rough Dilemma

Kia Rio 1.5L A5D 2000 - 2005

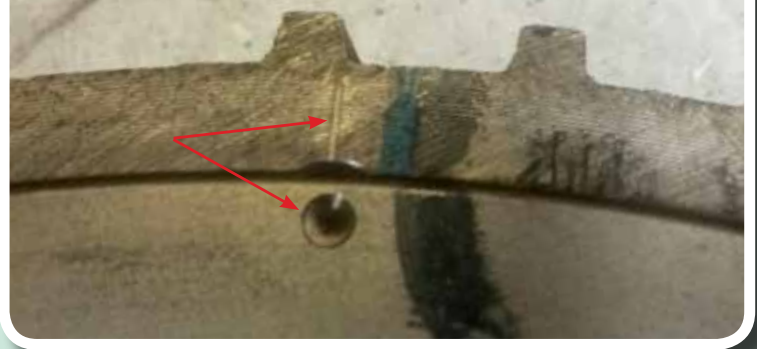
Timing mark on the flywheel & tone wheel aligned

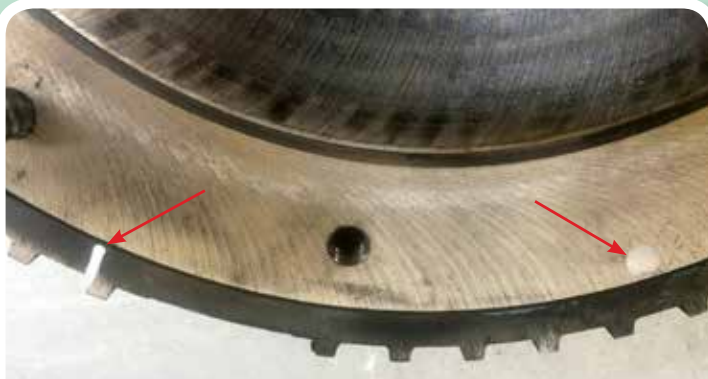
Eventually they removed the gearbox and flywheel. They bought a second hand flywheel for comparison and found that the tone wheel for the CKP sensor was in the wrong position. It was about 50 degrees out! ✓

The car came in with this flywheel. Shown with white paint, the timing marks on the flywheel & tone wheel are about 50 degrees apart.

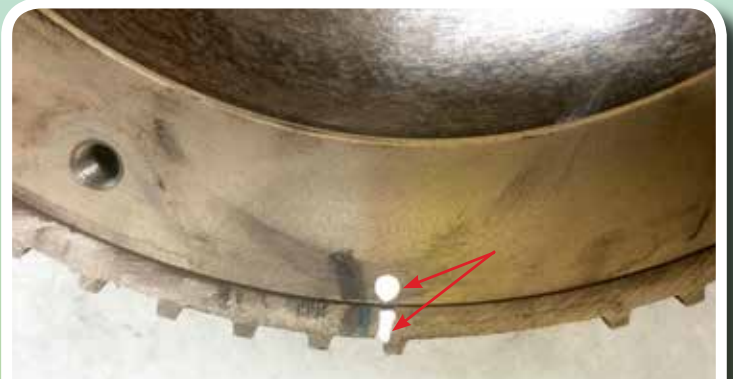
How it should have looked. Marks are aligned here. Notice the position of the missing teeth, compared to the original.
