# \*Urgent notice\*

## Service warning: BT-50 /Ford Ranger new generation 5cyl diesel models UP0YF1-

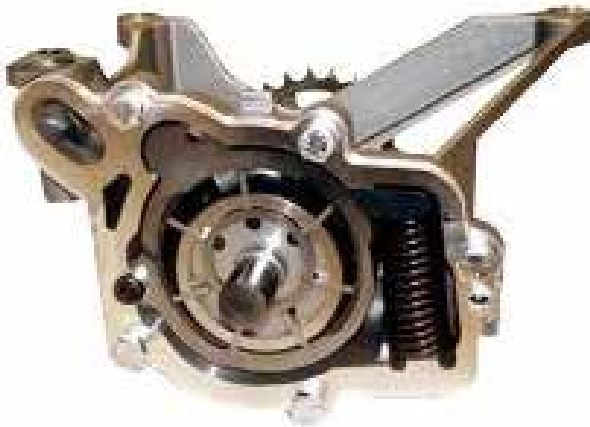
Reports to Autodata are that if the engine oil and filter are changed in service and the oil is left to drain longer than 10 minutes, the oil pump may fail to prime and leave the engine in a critical no lubrication situation. Attempts to prime the pump by increasing the rpm fails to solve the problem, and will lead to component failure from lack of lubrication.

A new feature in the BT50's engine is the variable-flow oil pump (similar in design pictured... left) that helps maximize fuel efficiency.

These variable flow pumps are much like power steering pumps, using vane elements in their design with the added ability to control flow rates at varied engine speeds. When the vehicle has the oil drained for an extended amount of time, the oil drains not only from the sump, but internally from the pump assembly. The vane type design appears to be less tolerable to being allowed to drain out and recover from that state thereafter.

**When draining the oil ensure that the total drain time does not exceed 10 minutes.**
