Case Study: 2008 Ford Transit 2.4 common rail Turbo Diesel

By Maurice Donovan (the MD)

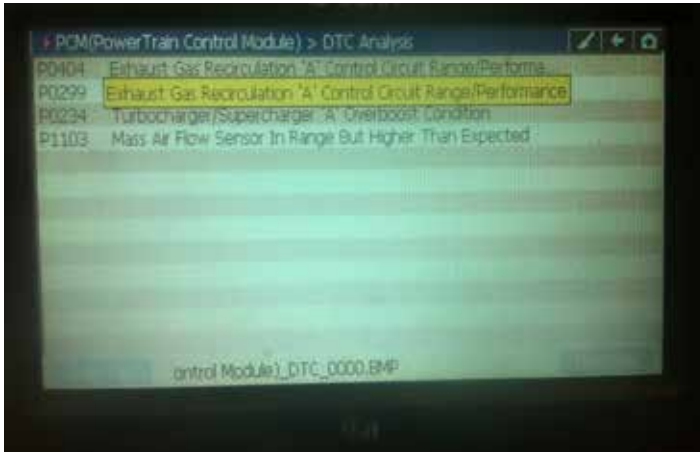
Before I made the call to my customer, I decided to remove the Boost sensor which happens to sit at the intake manifold opening. It was no surprise to see the excessive carbon build-up on this sensor and in the opening of the intake system.
