# Stray Current can kill a new radiator in just 3 weeks

Sometimes the most brutal cause of damage to vehicle components is unseen. This is an actual case involving an Aluminium radiator assembly which failed after only 3 weeks of service. Normally this component should last at least 3 years.

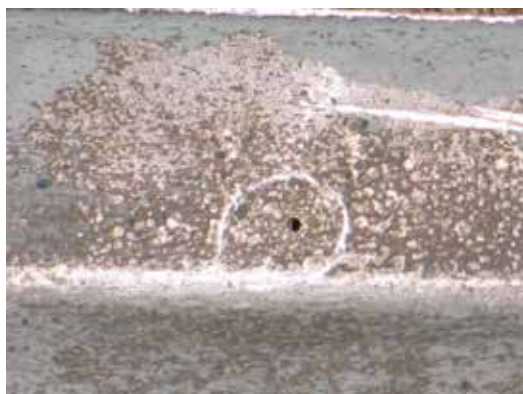
Cutting open a section of the tube where it leaked revealed pin holes to the surface of the tube wall as well as a build-up of foreign materials on the header plate.

Tube cut open to show pinhole.

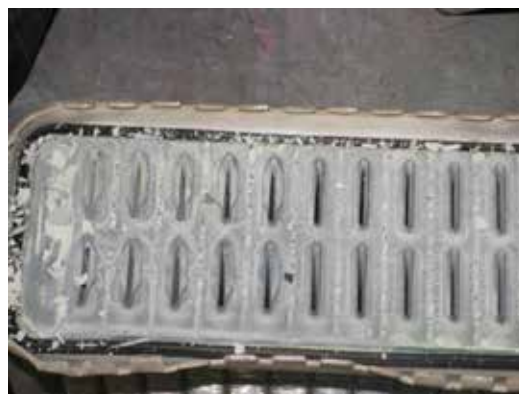
The end tubes (revealed when the tank was removed) had become soft and distorted.

End tubes have become soft and distorted.

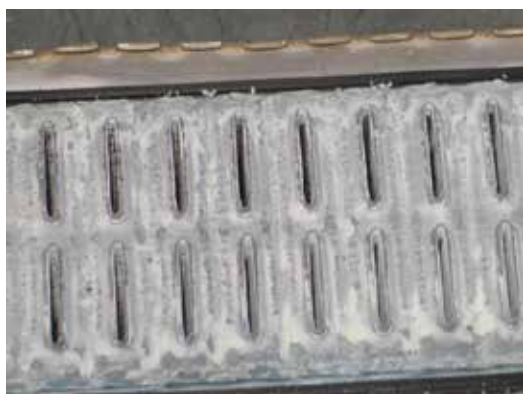
Header plate showing white deposits.

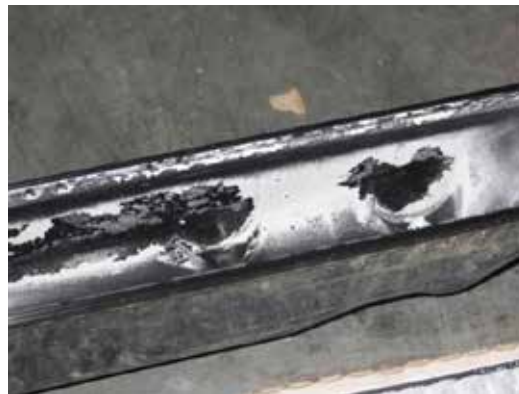
Conclusions: This radiator displays classic symptoms that make it easy to diagnose. It failed prematurely as a result of severe stray current corrosion (electrolysis) present in the cooling system. The give-away is the obvious build-up of aluminium hydroxide inside the tank. Aluminium is eroded away (sacrificial anode) during electrolysis, eventually wearing away enough material to cause a leak.

Tank coated with Aluminium Hydroxide.
