SYMPTOM: Appears that fuel pump has failed on 2011 Common Rail Diesel (CRD) Nissan Patrol ZD30 with only 43,000km. Fault code P1089 (Fuel pump) has logged in the computer.

The vehicle I am referring to in my diagnosis is the Nissan Patrol Y61 Wagon & U61 Utility year build- 2007- 2012 engine- ZD30DDTi fitted with Bosch CRD.

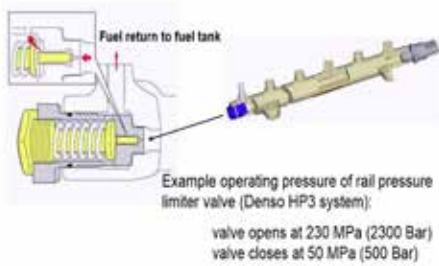
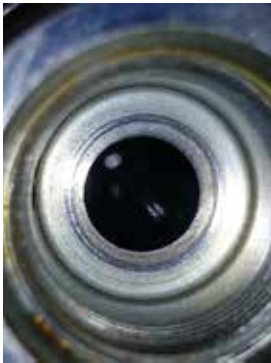
Rail pressure limiter valve

Often mechanics have gone straight to replacing the pressure relief valve at the end of the rail and not long after the fault re-occurs. What mechanics do not realise is that this valve must not be removed and refitted without being tested without the appropriate equipment. The only sealing for this valve is the knife edge seal between that of the rail and valve. Once that seal is broken (undoing the valve) there is no guarantee. The vehicle will be taken for a short 30 minute test drive and it may take up to a couple of weeks of until it occurs again- when your client is way out in the middle of nowhere- an expensive towing fee.

The only sure way to rectify the fault is to replace the entire rail and first we must test it to make sure we are replacing a \$1000 rail for the right reason. Looking at the rail located on the drivers side (right hand of engine). It is not difficult to see the rail once the engine cover and intercooler has been removed and you will see 4 pipes from the rail to the injectors. If you're lost here then you should not be working on this vehicle. At the front end of the rail (front of engine is the drive belt end), you

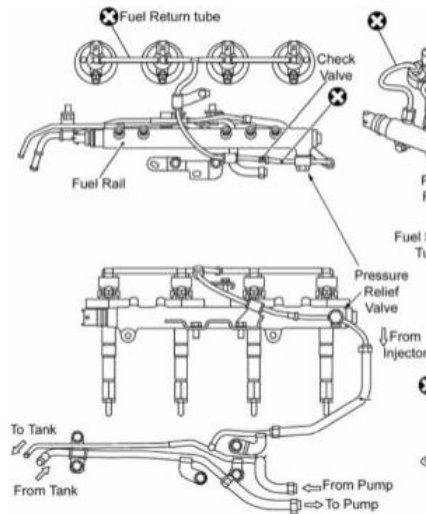
will locate a banjo bolt with banjo fitting. There is one small diameter hose from the injector return feeding in and then a larger hose returns to the tank.

We are looking for is a large leak from this fitting. This valve does not release until approx 1640 bar. You may find both or only one of the faults occurring-

off with compressed air. Make sure all exposed fuel pipes are capped immediately to avoid contamination. If the vehicle has only a starting issue, remove the banjo fitting and cranking the engine look for any fuel leaking out of the rail. There should not be any fuel present at this low cranking speed. If there is then BINGO! You have successfully diagnosed the fault and the rail must be replaced.

If the vehicle is experiencing the loss of performance only, then it will be necessary to replace the existing black fuel hose from the return with some clear hose. Make sure you still run the return back to the existing route. You will have to run a long enough hose to run outside the engine bay for you to inspect any early dumping of the fuel under load whilst driving. If this occurs either just before the fault appears or at the same time, BINGO! You have successfully diagnosed the fault and the rail must be replaced. The rail comes complete with a sensor and valve. On the Nissan Patrol it only takes about ½ an hour to replace.
