The Shocker Album

Problem Solving [®] M automotive electrical & air conditioning news

A new technical problem solving service from The Automotive Technician, under the guidance of **AAAE leaders**

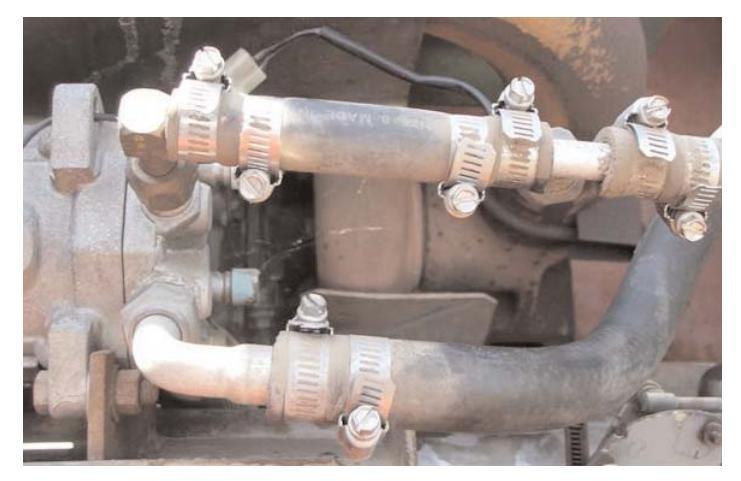
In this one photograph inside the engine room of a Massey-Ferguson tractor, there were eight hose clamps, holding together a patchwork of pipes.

"It looks like they ran out of hose, so stuck in an aluminium piece of tubing to make the distance.

"The problem with this sort of workmanship is that it leaves the way open for moisture to enter the system through poor connections. In this case, the whole hose work should have been replaced, and crimped with proper tools to eliminate the possibility of leakage.

The Massey-Ferguson was fitted with a Delco-Remy compressor at the factory, but this was ultimately replaced by a down-sized compressor - to save money, or through ignorance.

The result is that the aircon

doesn't live up to its OEM expectations because it can't pull enough refrigerant through the system quickly enough.

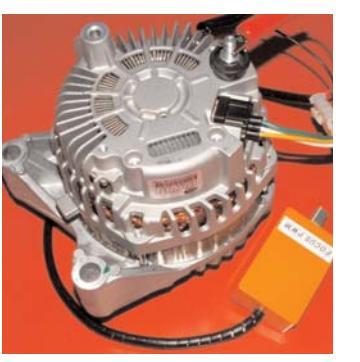
The AU alternator is a battery sense type and uses a regulator that requires both a sense (S) and a lamp (L) connection, marked '435' on the regulator's heatsink.

The BA alternator is a machine sense type and uses a regulator that only requires a lamp (L) connection, marked '517' on the regulators heatsink.

A problem will occur if an AU regulator is used when servicing the BA alternator, as the wiring loom in the BA does not provide a battery sense signal in the sense lead to the alternator. The warning light will stay on and a higher regulating voltage will be observed.

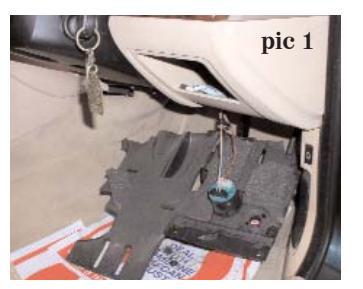
2) Remove the under dash panels on the drivers side to access the fan variable speed controller (pic 1)

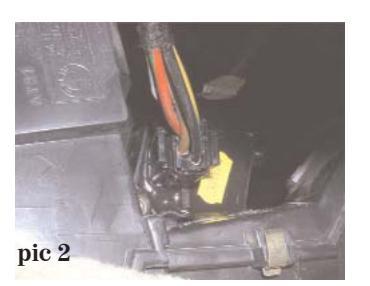
3) Find the variable fan speed resistor and check the wiring connections for power. (pic 2)

The fault is in the variable resistor that controls the fan speed for the internal ventilation system. (pic 3)

First you need the replacement part from BMW, Resistor part no. 64116923204. List price \$181.45+ (May 2006) Make sure that you check the chassis no. with BMW on ordering because they do vary between models.

Fit the new resistor into the hole with the two required screws, install the wiring and then test the fan operation. All should again be working correctly. You may also want to check that there are no error codes stored in the computer using an appropriate scan tool.

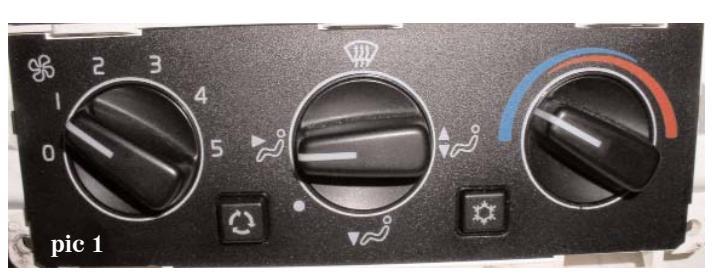
The fault is in the A/C compressor relay, which in this model is built into the main ventilation control panel.

All other functions for interior ventilation are working.

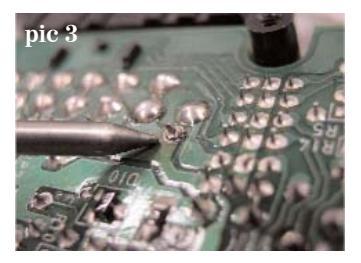
Inspect printed circuit board and locate main solder points for A/C compressor.

Re solder any poor or dry solder points as required. (pic 3)

Reassemble control panel, reconnect and test. All should again be working correctly. Recheck A/C performance and service A/C system if required.
