Denso Charging issues with a missing B+ Sense Supply

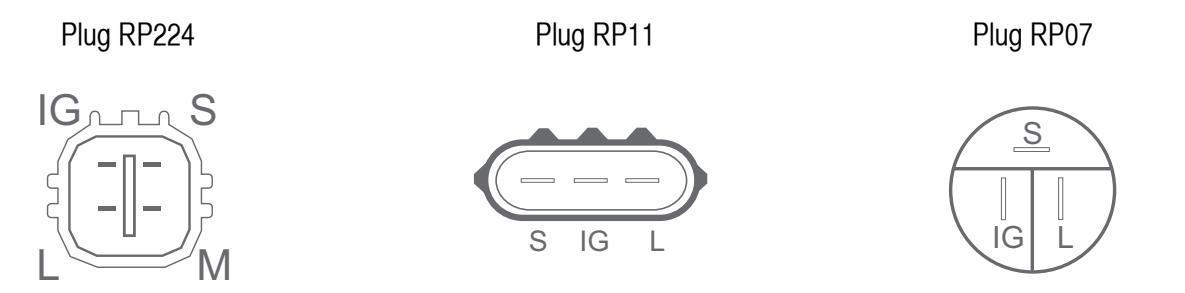
The Common 3 Pin round or Oval Plug has, Ignition, Light and Battery Sense and the early 4 Pin plug before ECU control has Ignition, Light, Battery Sense and M or FR which is essentially an Alternator output to advise the ECU how hard the Alternator is working.

The most common issue causing the light to remain on and still charge is lack of the battery sense supply. There can be any number of reasons for this to be missing from a blown fuse to a similar issue to a previous Tech Tip on Mitsubishi style plugs showing a Commodore with the Sense wire corroded off at the Battery Post.

Testing with Ignition on should show 3 terminals with 12volts on all 3 styles of plug.

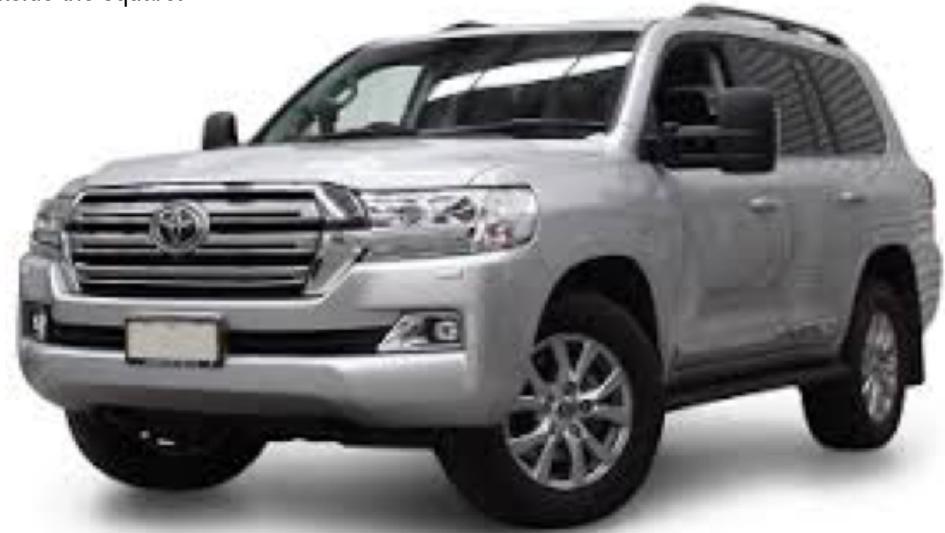
Thanks to Sam Pearson from Sam's Auto Electrical in Bendigo on this one, as he had a 200 Series Toyota Land Cruiser where the customer had conveniently "relocated" the Battery Sense fuse in the fuse box behind the battery into a spare fuse spot leaving the correct holder spot empty! Let's face it we look for blown fuses not missing ones! Talk about having to think outside the square.
