TECHNICAL BULLETIN

LEXUS INSTRUMENT DISPLAY

#T0141

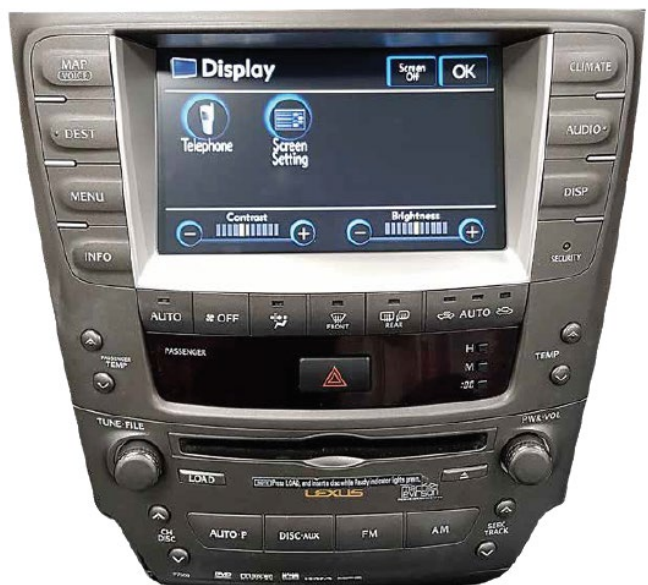
- Screen does not respond to touch
- Screen is blank
- Screen is cracked or broken

If you experience a vehicle presenting with a blank screen or the screen is failing to respond to touch, the unit should be removed and all connections to the back of the unit should be tested for correct fitment.

Once no fault is found with the connections, it can be determined that the unit is faulty. This is where Injectronics can offer a solution. Injectronics can provide a prompt test and repair service of the customers own unit. This will allow the customer to then refit the drivers original unit directly back into the vehicle saving time and money. It will also remove the need for any further programming to the car should a second hand unit be fitted.

Repair Part number: ICCLEXREP
