AC Tech Talk: Hidden Suction Hose Collapse.

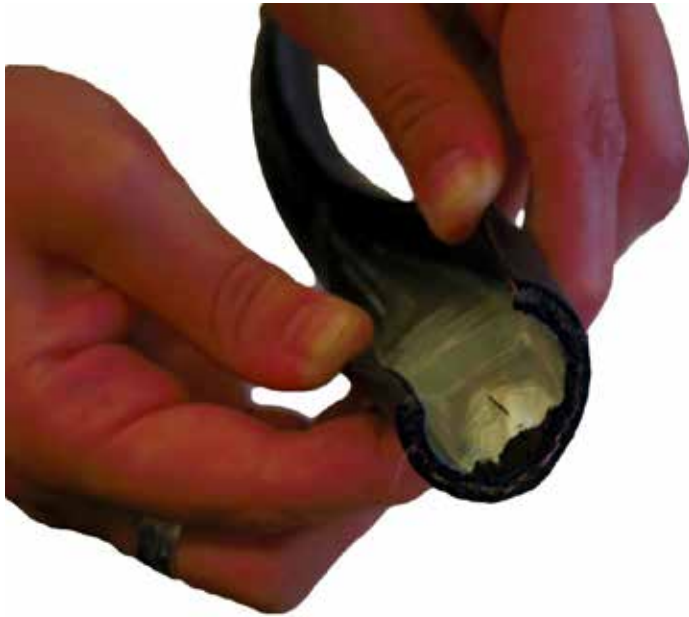
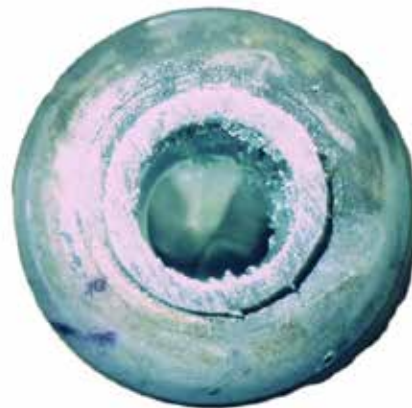
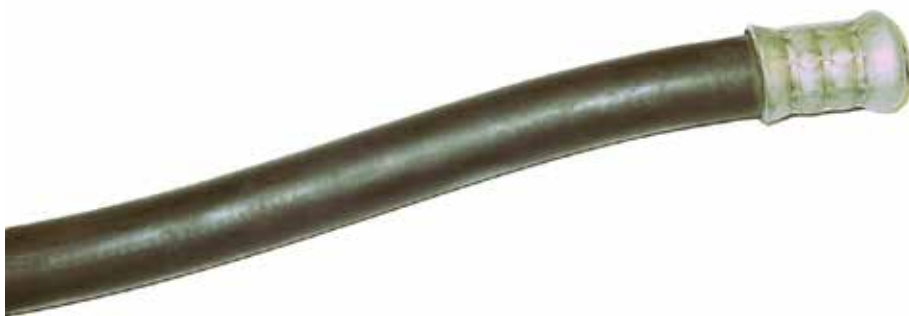
Have you ever seen a low side system restriction as a result of the suction hose collapsing? When I ask technicians this question they tend to tilt their head and look at me as if I have proposed the impossible, but this is not the case, at least not in systems that use a specific type of barrier hose. Barrier hoses exist as a result of advances in AC system performance technologies and they have great benefits such as reduced permeation (refrigerant loss) and water ingress, increased flexibility and life span; and in the case of plastic inner sleeve hoses you see a reduced friction, an increase in system performance and less operation noise in the cabin. It is this plastic inner sleeve that can collapse, causing a low side system restriction or blockage. The picture to the left and below are of a suction hose cut out of a Subaru Liberty and shows an inner layer collapse.

So how do we identify a suction hose inner collapse or restriction? In reality this fault is extremely difficult to diagnose as it displays itself on the gauges as a restriction in the TX Valve. Further, when diagnosing a system with a variable compressor the fault can be masked as the pump 'varies' its stroke according to the returning suction pressure. Therefore a system can look to be working, though in time, the restriction in the suction hose will starve the compressor causing it to overheat. Visually you cannot see the hose collapse as only the inner layer does so while the outer layer maintains a perfect structure, and blowing through the hose with air will only force the collapsed barrier open and not reveal any restrictions. The only way to verify a collapsed suction hose is by cutting it open to inspect!

Suction hose collapses are a rare occurrence and you would not suspect this fault every time a system presents itself with a low side restriction, however be aware that more and more manufacturers are using plastic inner sleeves and this fault is becoming more common.

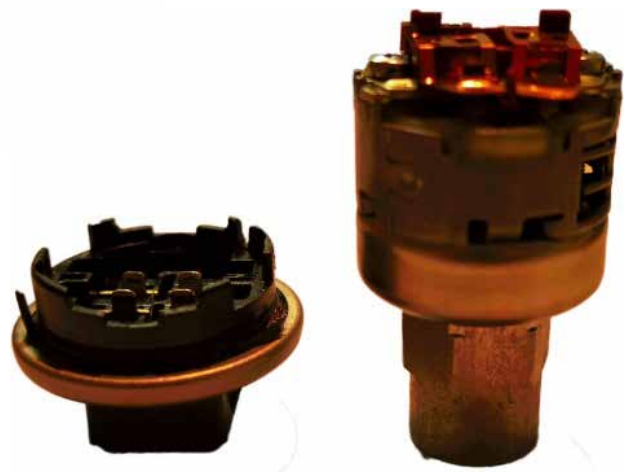
The transducer switch pictured below (OE# 1K0-959-126) is common throughout the Volkswagen Golf IV, V and VI series and many Audi vehicles of the same years. The switch has been found to display a common fault of an internal leak in its mechanical components causing a loss of refrigerant and electrical short circuit. The switch pictured below suffered a leak so large that it separated in two. When looking for a leak in the Audi or VW range, be sure to check under the plug of this transducer for oil residue.

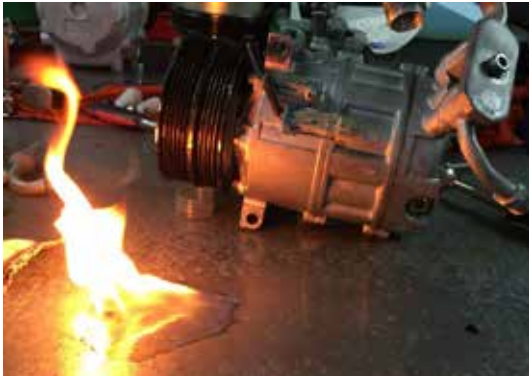
AC system flushing is a very important process when you are repairing a system that has suffered a catastrophic compressor failure, however be aware that it is as important to remove all traces of flush! Below is a picture of the oil that was drained from a new variable compressor that had failed to pump correctly. The oil is easily ignited as it is contaminated with flush.

Variable compressors rely heavily on the maintenance of oil levels and oil types in the system. If the oil viscosity is changed or liquid (flush) is mixed with the oil, the control valve will become fowled and fail to stroke the compressor. Remember that when flushing you should always leave air running through the hoses until they blow dry and avoid flushing parallel flow condensers and evaporators if a replacement part is easily available and fitted. Also be sure to choose a flushing compound that is highly evaporative and non-oil based or it will be hard to remove from the system. If you are unsure, contact your local AC supplier for more information.
