# Stray Current can kill a new radiator in just 3 weeks

Sometimes the most brutal cause of damage to vehicle components is unseen. This is an actual case involving an Aluminium radiator assembly which failed after only 3 weeks of service. Normally this component should last at least 3 years.

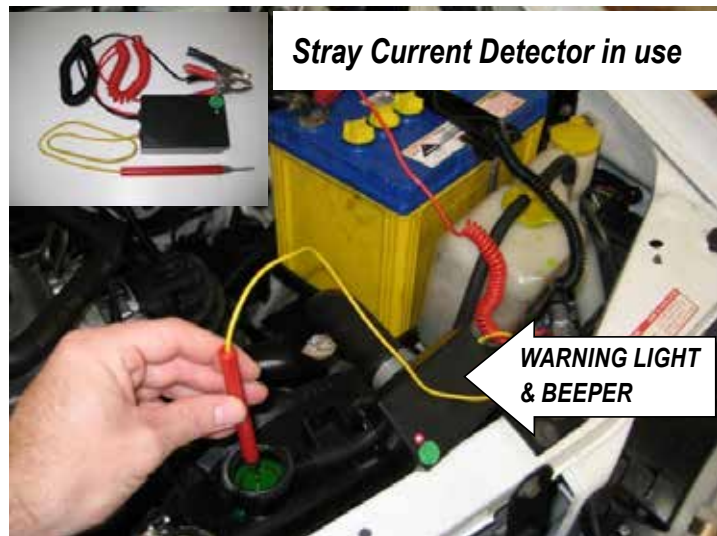
- A. Use a stray current detector (shown) or an analogue multimeter with impedance of around 100k Ohms per Volt and lowest test scale of 0–0.5 Volts (many digital multimeters are unsuitable as they generate a small current down the probe).
- B. Connect the detector (or multimeter) and place the probe into the radiator filler neck until it touches the coolant.
- C. A flashing light/tone or reading greater than 50 mV (0.05 V) means stray current is present and remedial action is required.
- D. Usual causes of stray current are damaged wiring insulation, faulty or incorrectly installed fans, faulty relays or earth straps missing or covered in paint overspray following panel repairs.
