REDARC

TECHNICAL TIPS

Voltage Changes to our SBI12 SmartStart

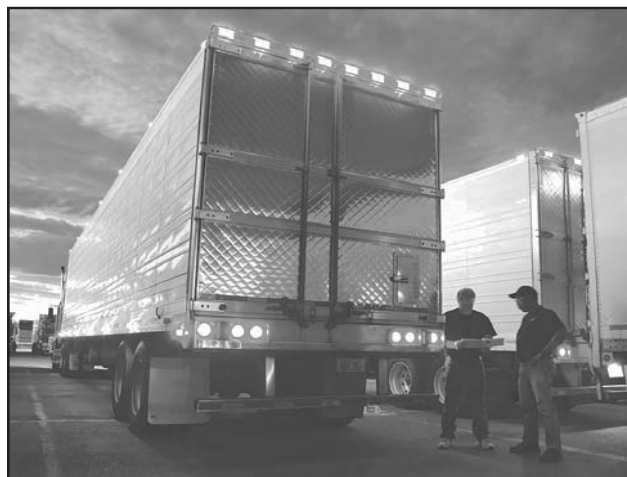
Fit a REDARC LDLB product to the trailer, LDLB12 (for a 12V trailer) LDLB24 (for a 24V trailer). LDLB means LED Dummy Load Brake.
